INNOVATIVE DIVING EQUIPMENT TRADING LLC

DIVING DECOMPRESSION CHAMBER WITH 3 DIVER MIX GAS PANEL IN 20FT CONTAINER

INSPECTION REPORT No: DBA.4.24.1167.291124.IR-05.KG Revision No: 0

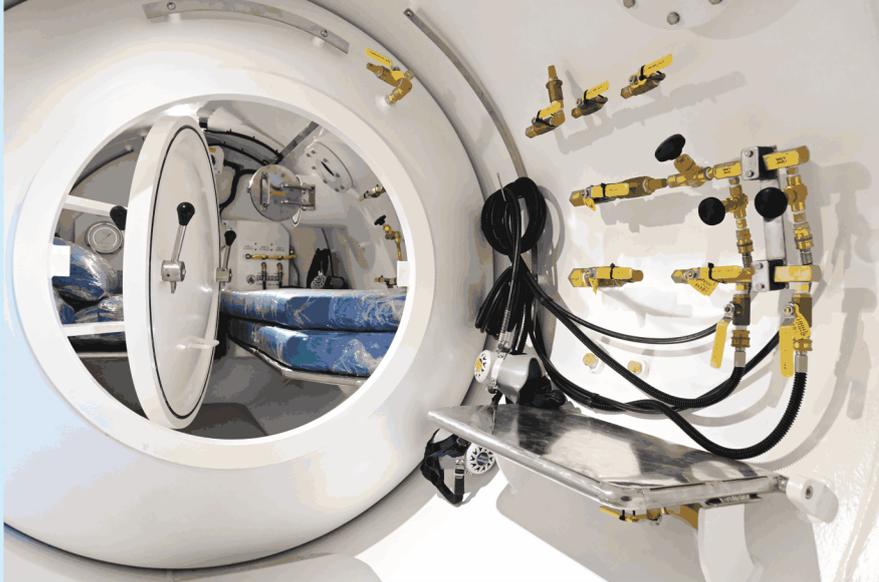
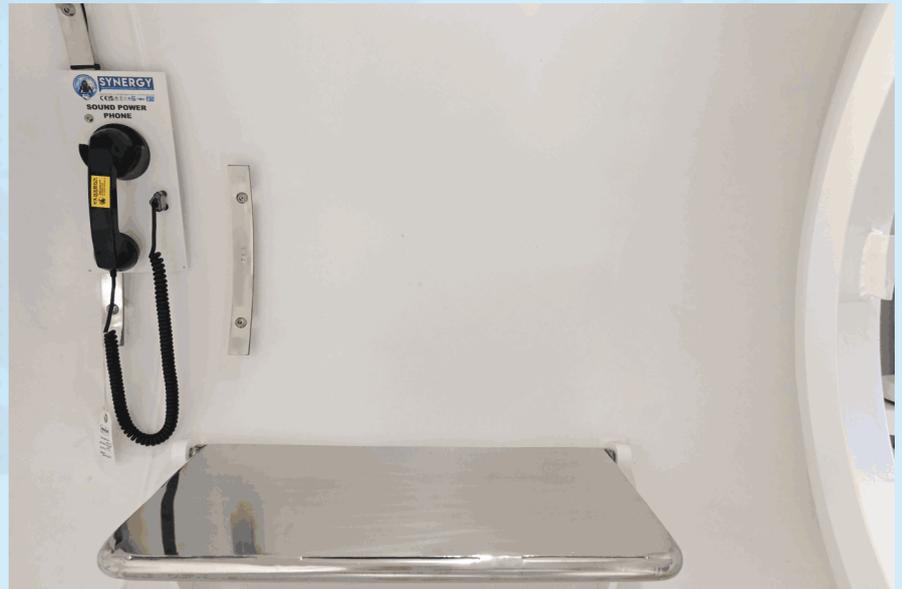
CHAMBER ENTRY LOCK WITH ALL FITOUT AS BELOW

Sr.	Part Number	Description	Qty
1	SY-SP-V	Viewport	1
2	SY-350M-01	Amron avox hyperbaric bibs, dual hose ,350 msw rated	2
3	SY-7140-01	Amron led hyperbaric light unit	1
4	SY-3114	Amron internal talk back speaker	1
5	SY-SPT-550RC	Sound powered phone	1
6		Stainless Steel foldable seats	2
7		Aluminum checkered floor plate	1
8		Drain valve connected with flexible hoses for flushing	1
9		All valves and fittings as required

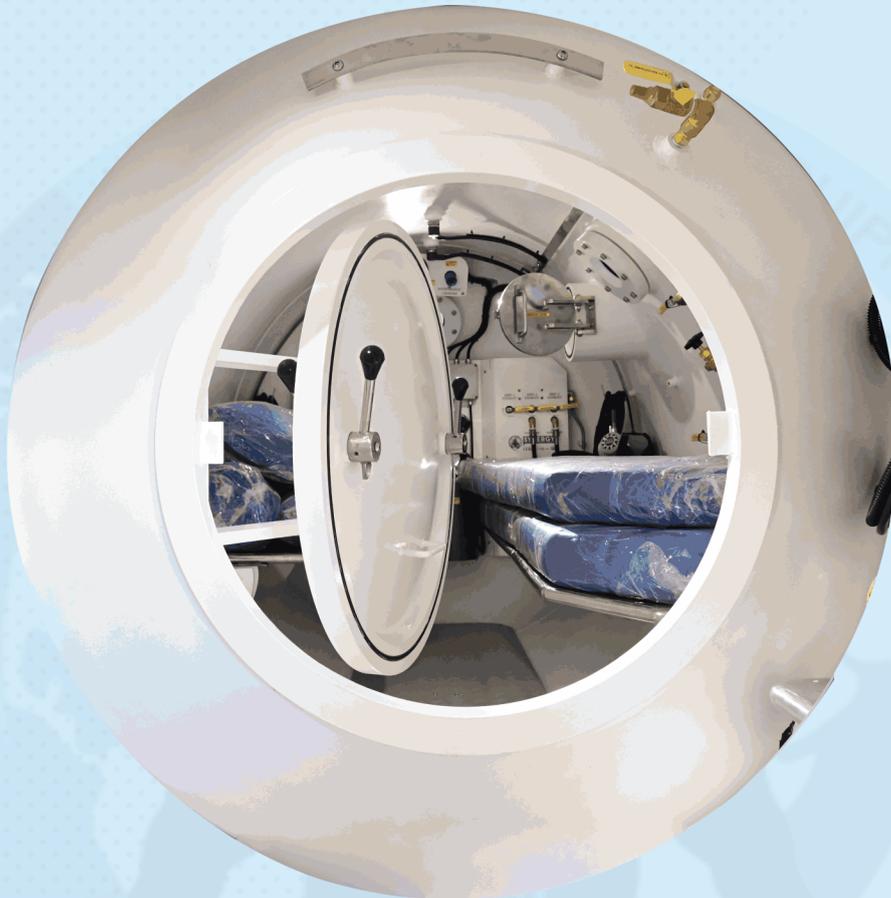
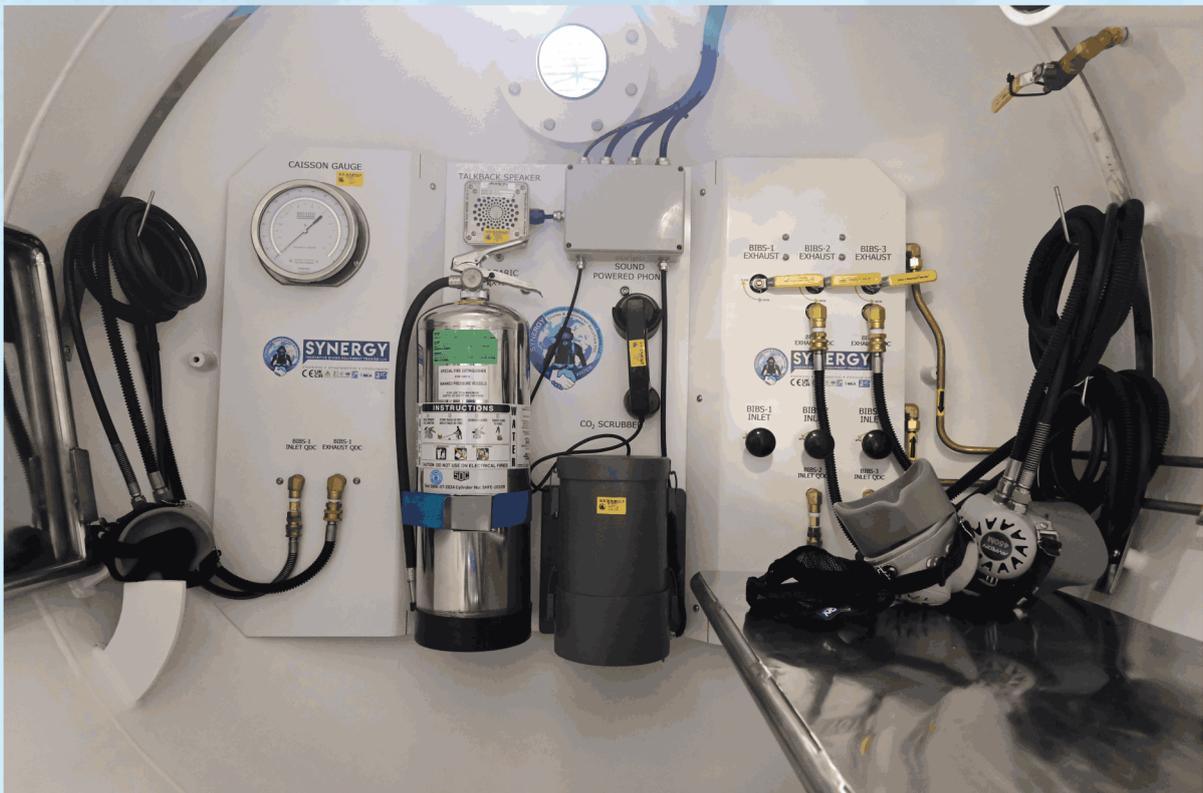
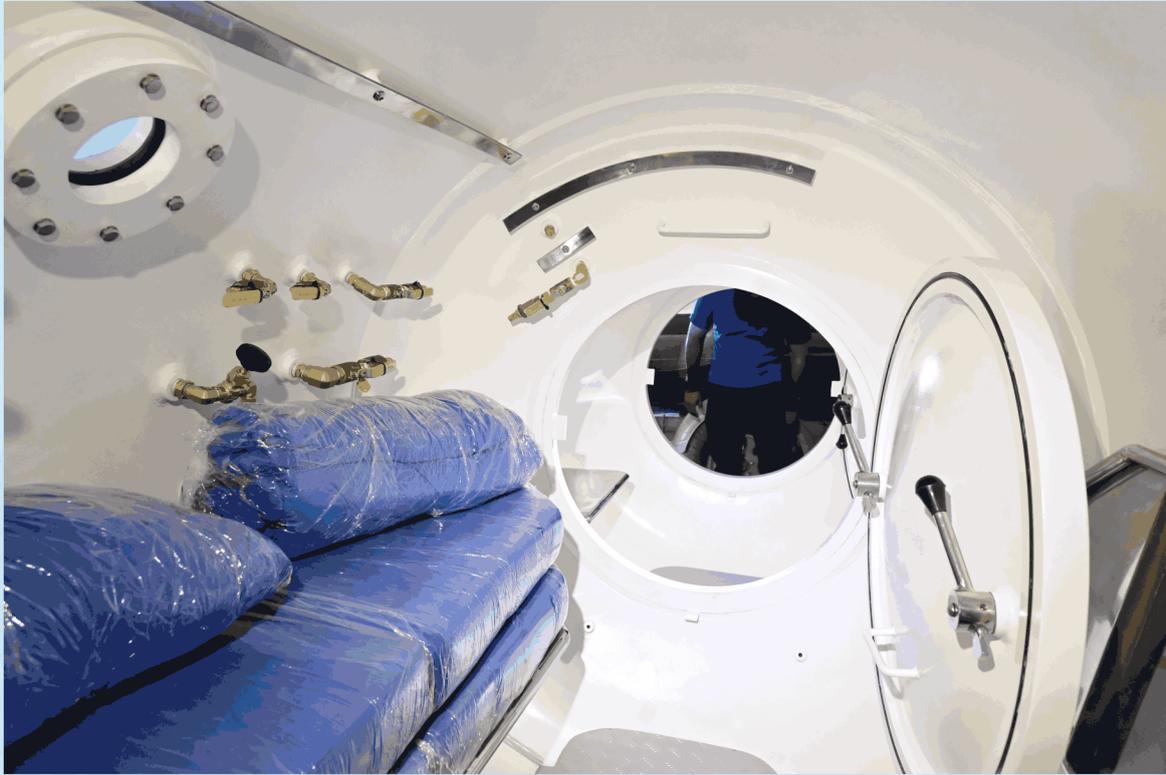
CHAMBER MAIN LOCK WITH ALL FITOUT AS BELOW

Sr.	Part Number	Description	Qty
1	SY-SP-V	Viewport	2
2	SY-SP-VSY-240-FE	Amron Hyperbaric fire extinguisher	1
3	SY-CO2-SCR	Synergy Co2 scrubber unit, 12v, stainless steel	1
4	SY-350M-01	Amron avox hyperbaric bibs, dual hose , 350 msw rated	3
5	SY-7140-01	Amron led hyperbaric light unit	1
6	SY-3114	Amron talk back speaker internal	1
7	SY-CG-230	Internal caisson gauge, 0-230 fsw	1
8	SY-SPT-550RC	Dynalec sound powered phone	1
9	SY-UWC-325/P/E	Internal hyperbaric camera with view of main lock connected to monitor on chamber panel	1
10	SY-EP-4C	Electrical penetration	2
11	SY-FRM	Hyperbaric fire retardant mattress (one for each bed)	1
12	SY-FRP	Fire retardant pillows (one for each bed)	1
13		Stainless Steel foldable beds	2
14		Aluminium checkered floor plate	2
15		Drain valve connected with flexible hoses for flushing	1
16		All valves and fittings as required	1
17		Air - all tubing will be stainless steel with brass fittings	1

18		Oxygen- all tubing will be tungum with brass fittings and O2 approved Teflon tape

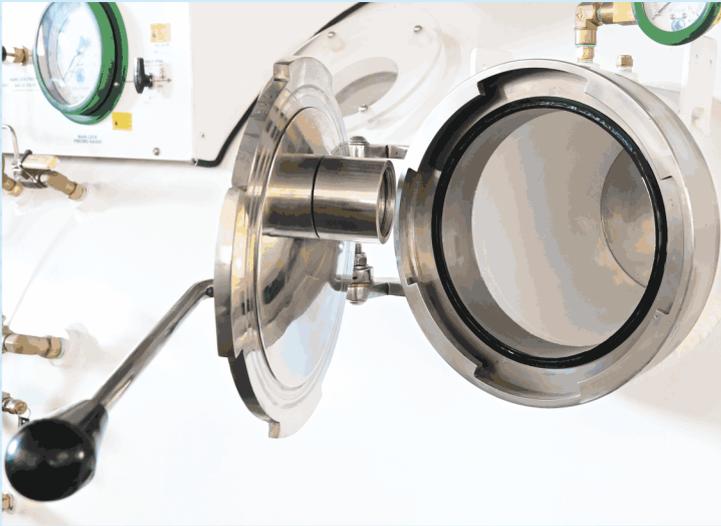
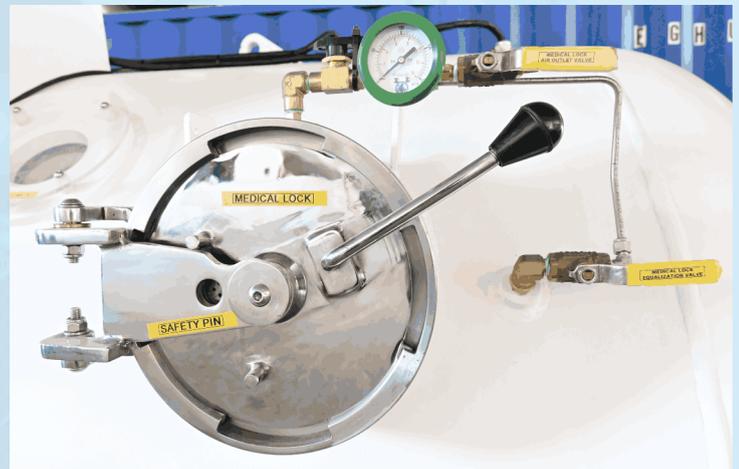
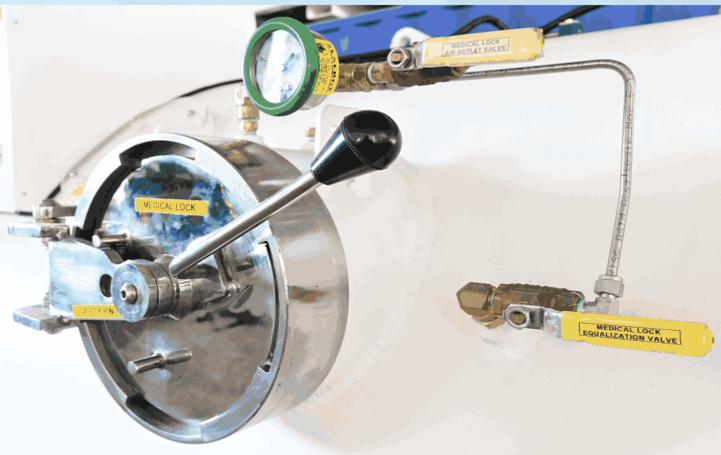
CHAMBER MEDICAL LOCK – STAINLESS STEEL WITH AUTOMATIC INTERLOCK

Sr.	Description	Qty
1	External Medical lock, stainless steel with easy to use handle (for open/ close)	1
2	Internal medical lock door, stainless steel	1
3	Automatic interlock (will lock external door under pressure) (door cannot be opened when interlock is engaged)	1
4	Equilization valve	1
5	Pressure gauge with valve (to show pressure inside medical lock)	1
6	Silencer	1

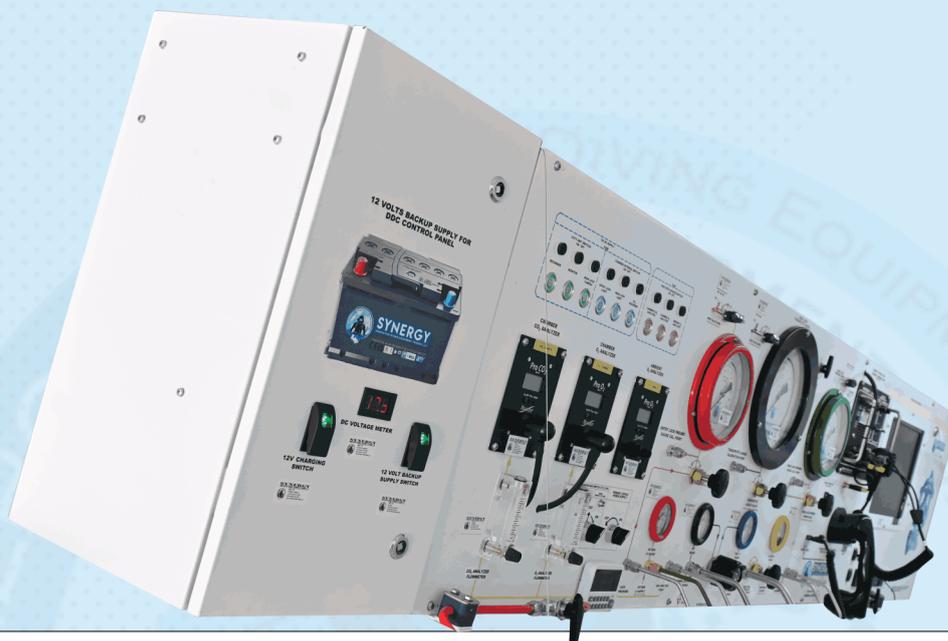
CHAMBER CONTROL PANEL – INCLUDING HP MANAGEMENT PANEL

0-230 fsw/70 msw Depth gauge, 6", 0.25 % accuracy, mirror scale, with calibration point ,
Entry lock, Color coded **Red**

1 x 0-230 fsw/70 msw Depth gauge, 6", 0.25 % accuracy, mirror scale, with calibration point ,
Main lock, Color coded **Green**

1 x 0-70 fsw/21 msw Depth gauge, 8.5", 0.25 % accuracy, mirror scale, with calibration point ,
Therapeutic, Color coded **Black**

Sr.	Part Number	Description	Qty
1	SY-PRO-O2	Oxygen analyzer (O2) with high low alarm connected with a Dwyer VFA 22 BV flow meter to chamber (can read from both entry and main lock by opening valve as required)	1
2	SY-PRO-CO2	Carbon dioxide analyzer (CO2) with high alarm connected with a Dwyer VFA 22 BV flow meter to chamber (can read from both entry and main lock by opening valve as required)	1
3	SY-PG-O2-2.5-500	Gauge for oxygen supply to chamber (oxygen approved gauge)	1
4	SY-PG-A-2.5-500	Gauge for low Pressure air supply to chamber	1
5	SY-2820A-02	chamber communicator, Amron (with push to talk microphone)	1
6	SY-873-400	Option 1 Aqua environment high pressure regulator w/gauges	
7	SY-SPT-550RC	Dynalec sound powered phone (connected to entrance/main lock spt)	1
8	SYTRAN220/24/12	(2 x 24v, 2 x 12v, switch for emergency battery power)	1
9	All inlet and outlet connections provided on the panel frame itself

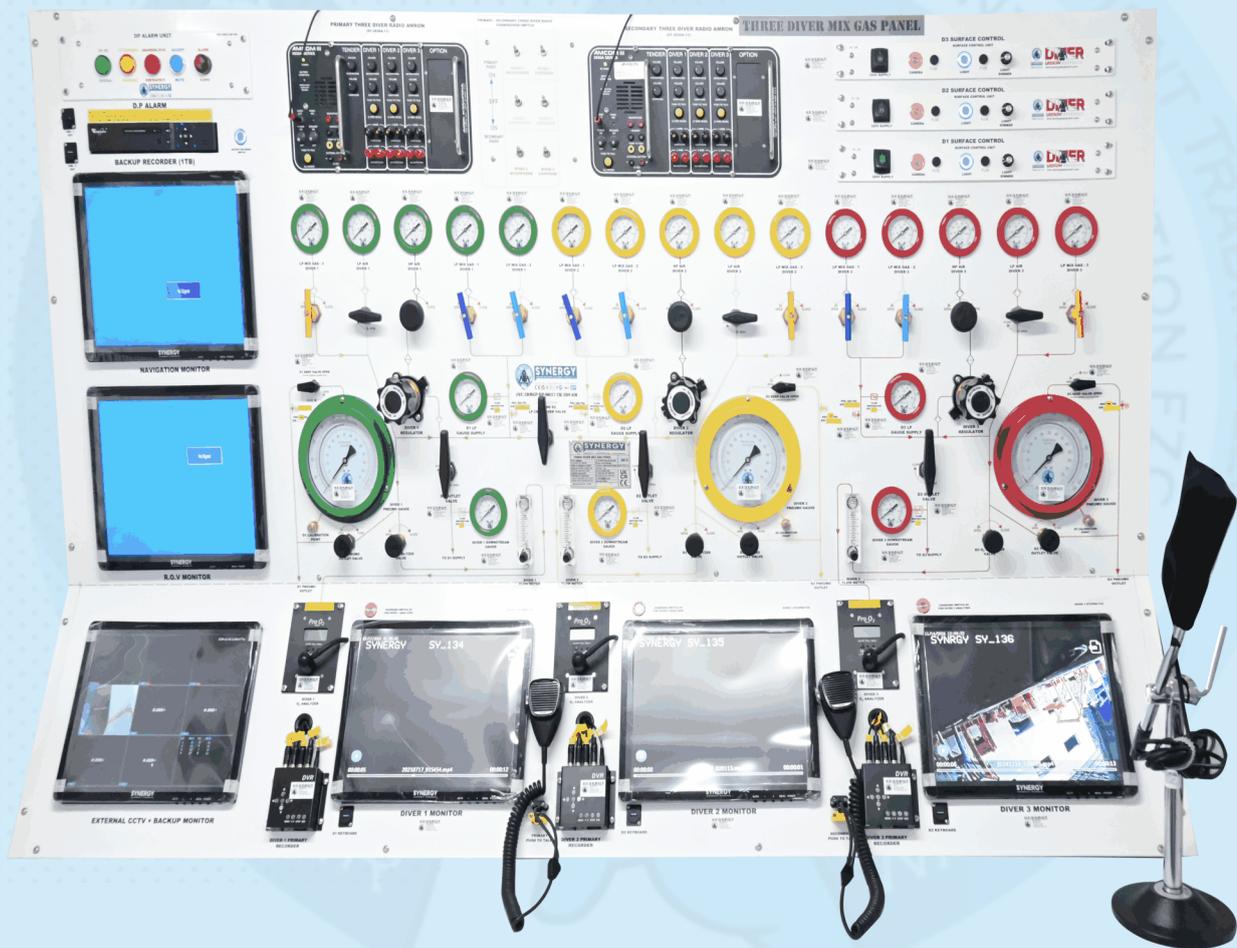
THREE DIVER MIX GAS PANEL (BACK PLUMBING) SY-3DMG-D037-XR-XDV-XM

Part Number: SY-3DMG-D037-2R-3DV-6M

Sr.	Description:
1	Powder coated aluminum non rust facia
2	All engraved lines with each valve/fitting/regulator etc clearly marked
3	SS Frame mounted
4	Backside access through container rear door, rubber lined to prevent water ingress (enables easy visuals, repairs, maintenance etc as required on the panel).
